### *Detection of cavities under concrete pavement*

# CRREL Report 83-18

July 1983

Austin Kovacs and Rexford M. Morey

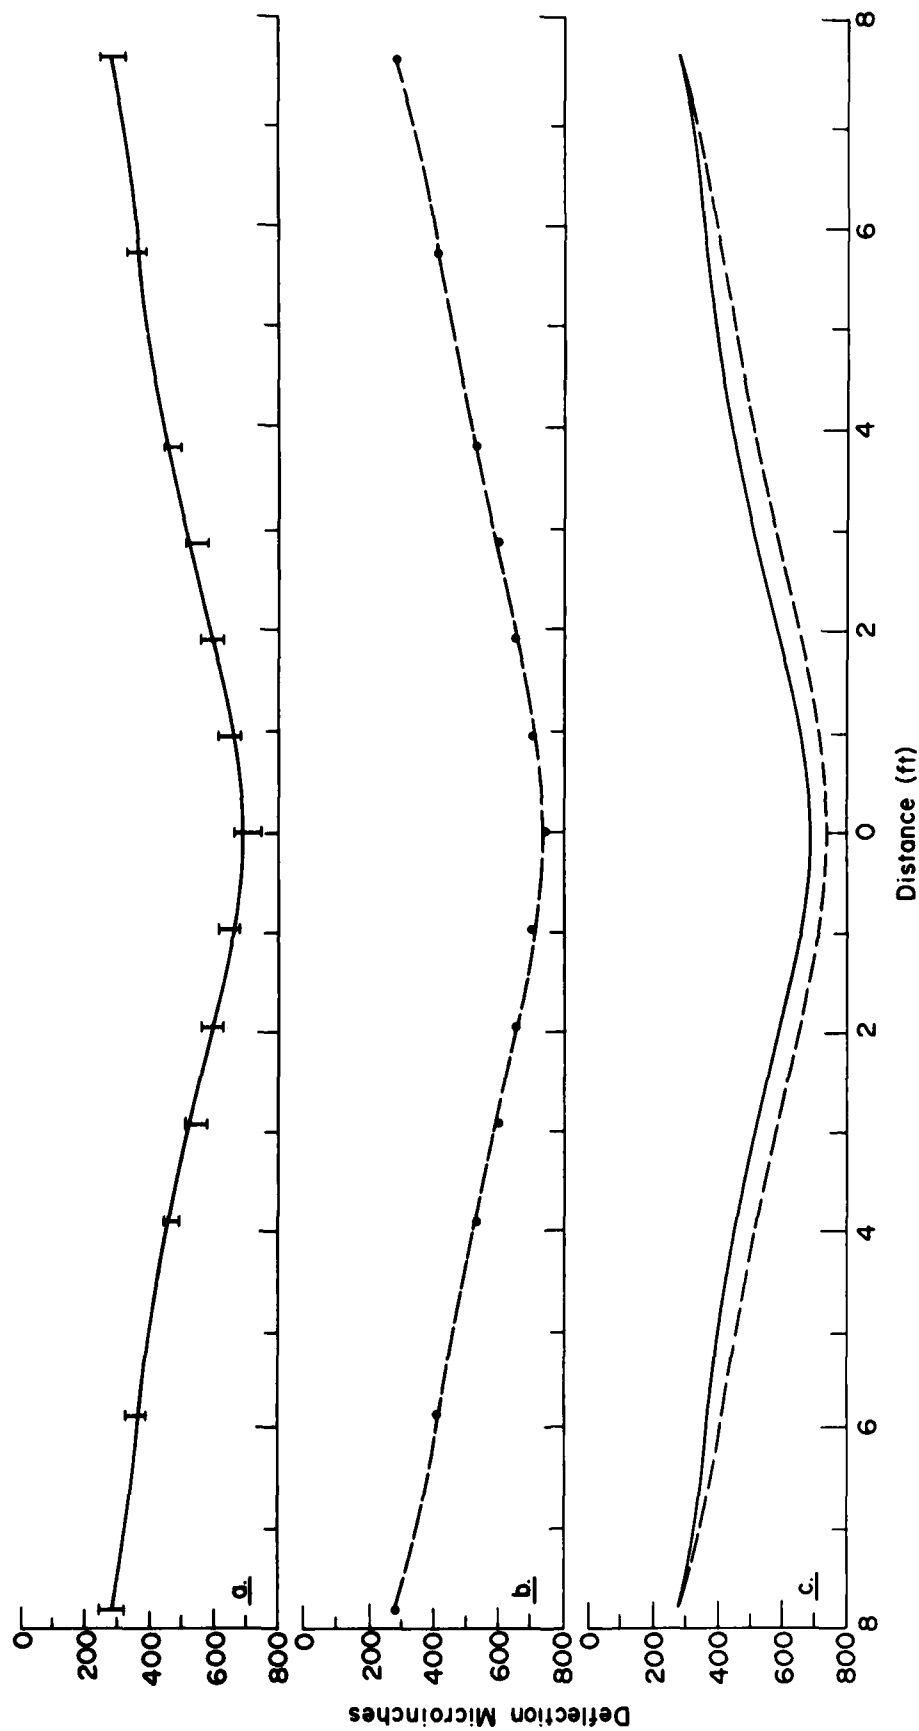
FWD tests were made on slab 1 of rows 9H, I, K and L as well as row 9J. The impact force was about 23,000 lbs or 210 psi under the 11.8-in.-diameter base plate. Six drop tests were made at the center of each slab. The deflection data for each slab were then averaged. The averaged deflection data from the FWD tests on supported slabs 9H, I, K and L and partially unsupported slab 9J are plotted in Figure 38a and 38b, respectively. The third-degree polynomial regression curves passing through the data in Figures 38a and 38b have correlation coefficients of 0.998 and 0.999, respectively. In Figure 38c the deflection curves are presented together. These curves show, as expected, that the partially unsupported slab deflected substantially more under the force impulse than the supported slabs. These results indicate that the FWD test may be used instead of drill holes to verify the existence of a subpavement cavity detected by impulse radar profiling. The FWD test may also be used as a substitute cavity detection device. It would, however, be much more time consuming to use than the radar system. The FWD tests at Plattsburgh AFB were limited in number. Further tests need to be made before the FWD can be considered to be an acceptable method for detecting or verifying the existence of cavities below concrete pavement slabs determined with impulse radar sounding.

Figure 38. Deflection of four supported slabs (a) and one partially unsupported slab (b) vs distance from the center of the FWD impact plate. The bars in curve a represent the spread of the averaged FWD test deflection data from the four slabs.
